Subject: **Phase II Environmental Site Assessment**
Residential Property (unoccupied)
110 Herman Avenue
Wadsworth, Nevada
Converse Project Number 17-23161-02 (.1,.2,.3, and .4)

Subject: Asbestos Survey
Residential Property (unoccupied)
110 Herman Avenue
Wadsworth, Nevada
Converse Project No.: 17-23161-02.1

RISK ASSESSMENT AND LEAD INSPECTION REPORT

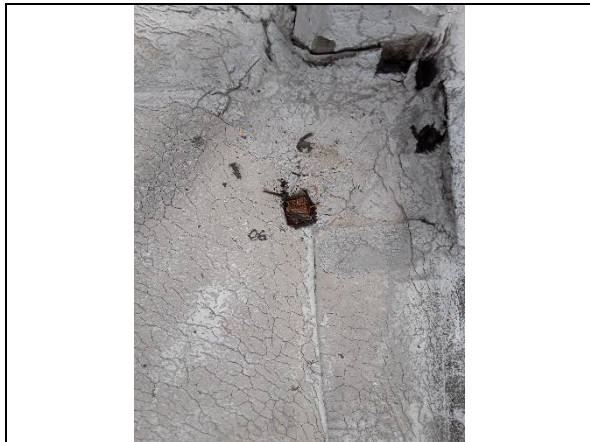
1. ACM Roofing Material With Silver Paint

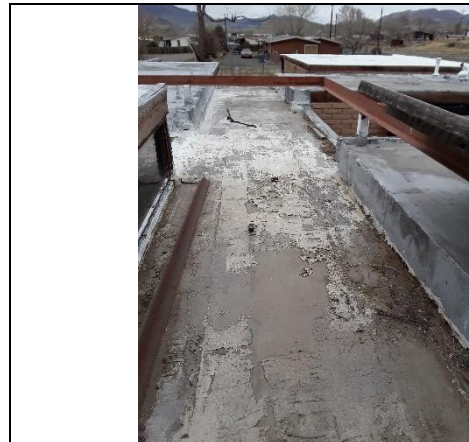
4. ACM Roof View Looking North

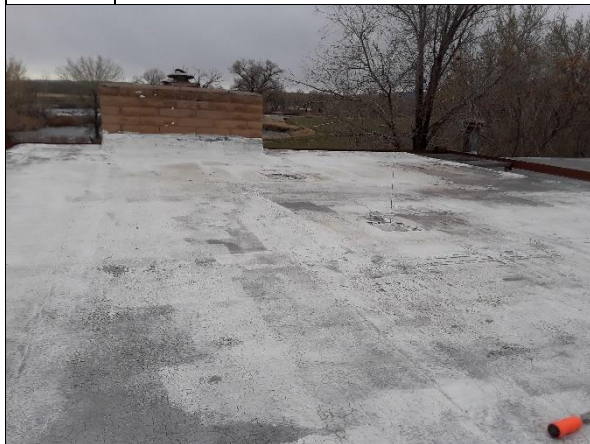
2. ACM Roof View Looking East

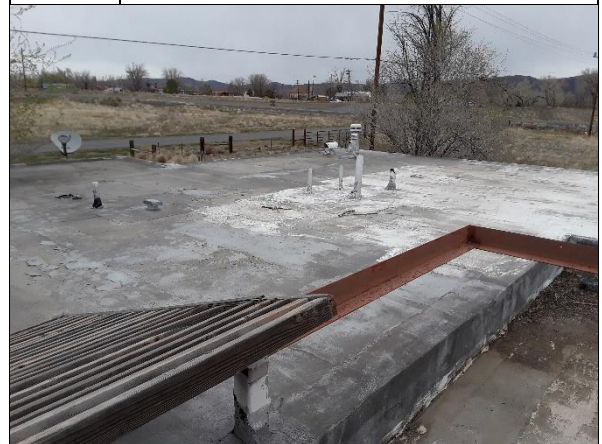
5. ACM Roof View Looking West

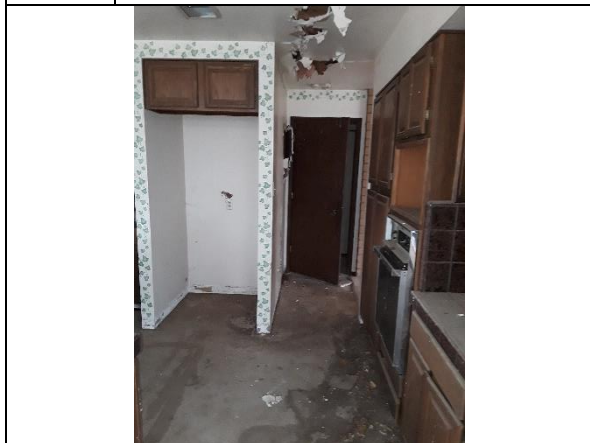
3. RACM Sheet Flooring Remnants In Kitchen

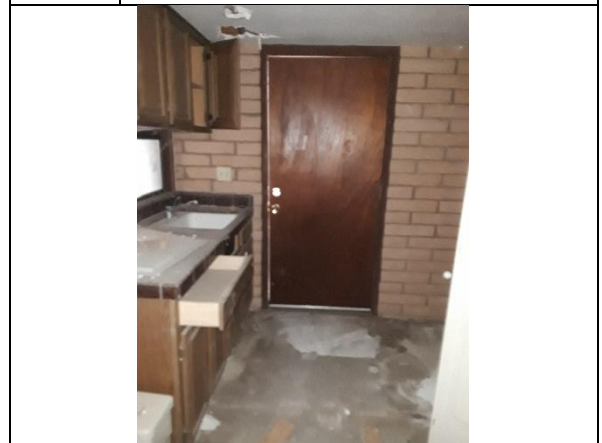
6. RACM Sheet Flooring Remnants In Laundry

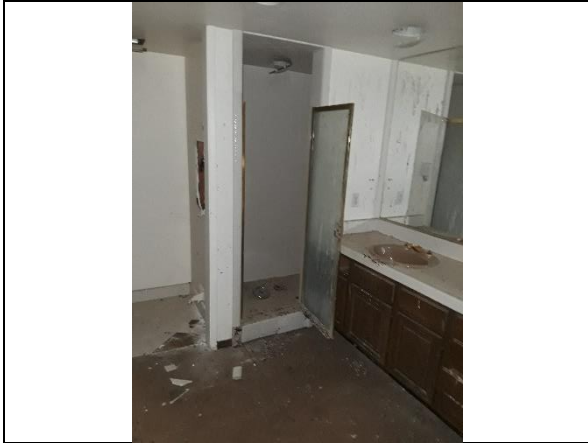
7. ACM Tile Mastic Bathroom

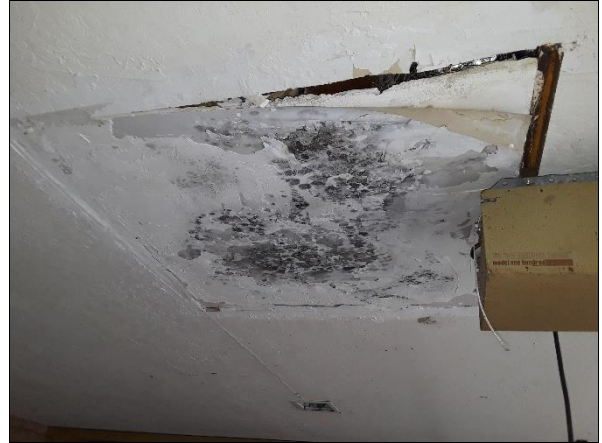
10. Moldy Drywall In Garage Tested <1% (Trace) For Asbestos Fibers

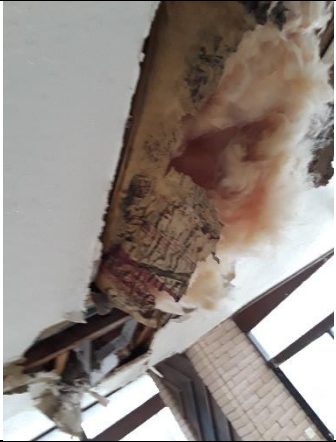
1.	Mold Present on Fiberglass Insulation Living Room

1. Per the visual inspection and fungal air sampling results the impacted drywall and insulation throughout the residence should be cleaned or removed per the methods and procedures found in the ANSI/IICRC S520-2016 Standard. This includes visible mold on structural wood studs (remove mold and encapsulate) and the HVAC system and associated duct work (clean or remove and replace if cleaning not practical).
2. Contents of the home including non-porous objects (wood, metal, plastics) and porous objects (fabrics, fibers, carpet) should also be disposed.

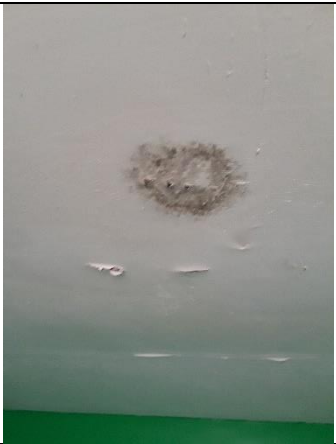
2.	Moisture Staining and Visible Mold In Bedroom

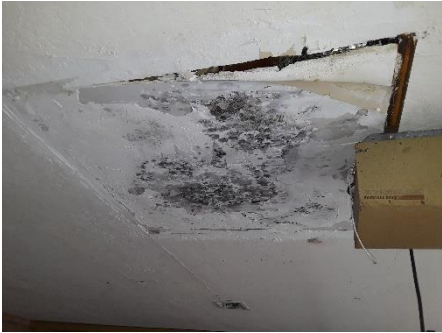
3.	Visible Mold on Garage Ceiling

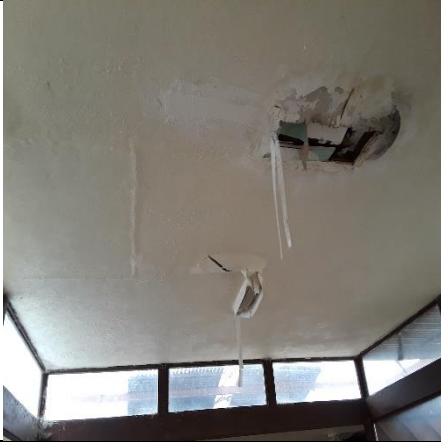
4.	Water Damaged Ceiling In Living Room

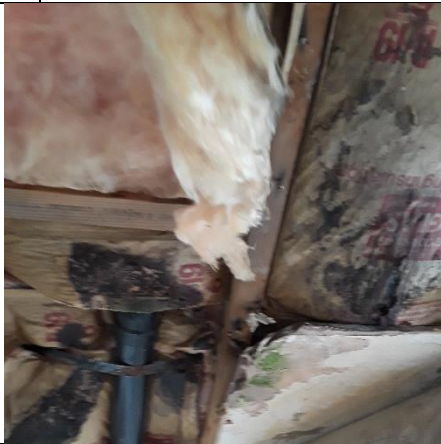
5.	Visible Mold On Wood Joists and Insulation

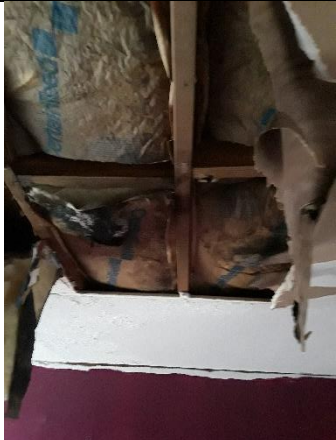
6.	Visible Mold on Wood Joists in Bedroom

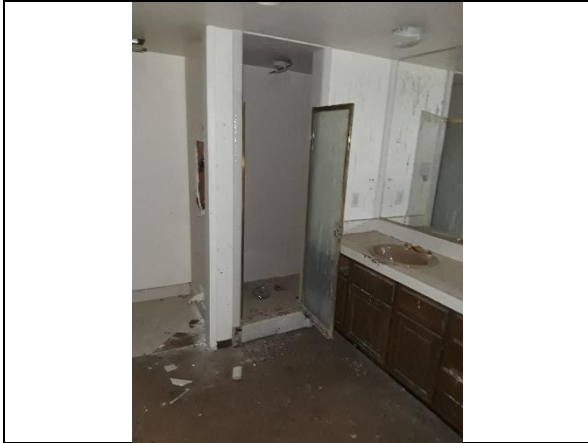
7. ACM Tile Mastic Bathroom

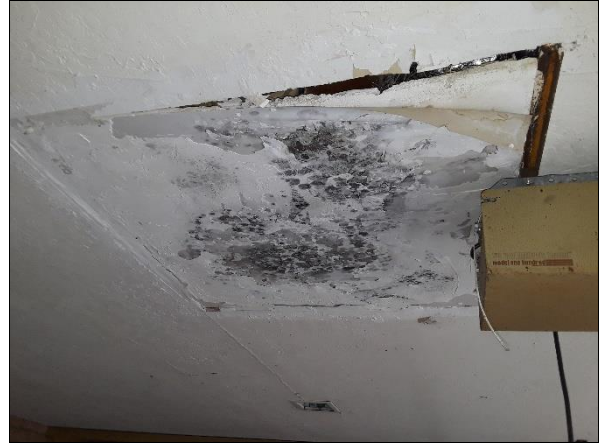
10. Moldy Drywall In Garage Tested <1% (Trace) For Asbestos Fibers

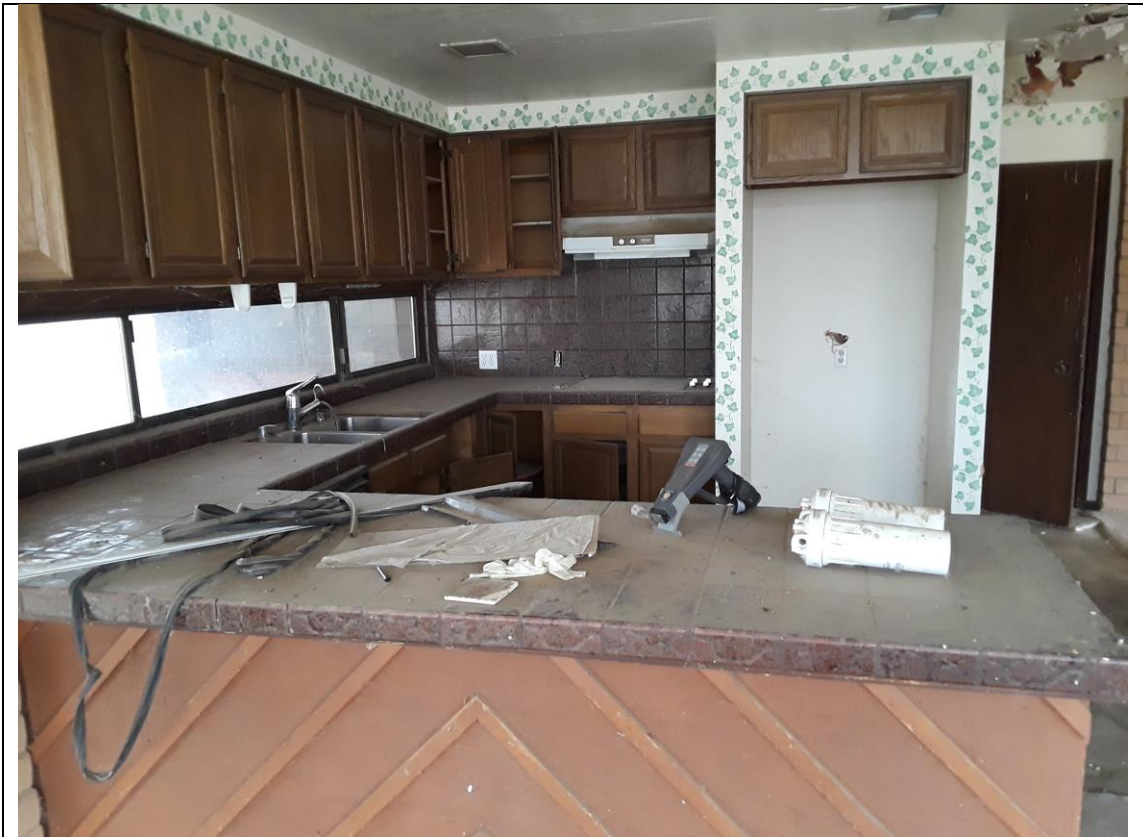
Photograph #1: Lead containing brown tile (glaze) on counter and backsplash.

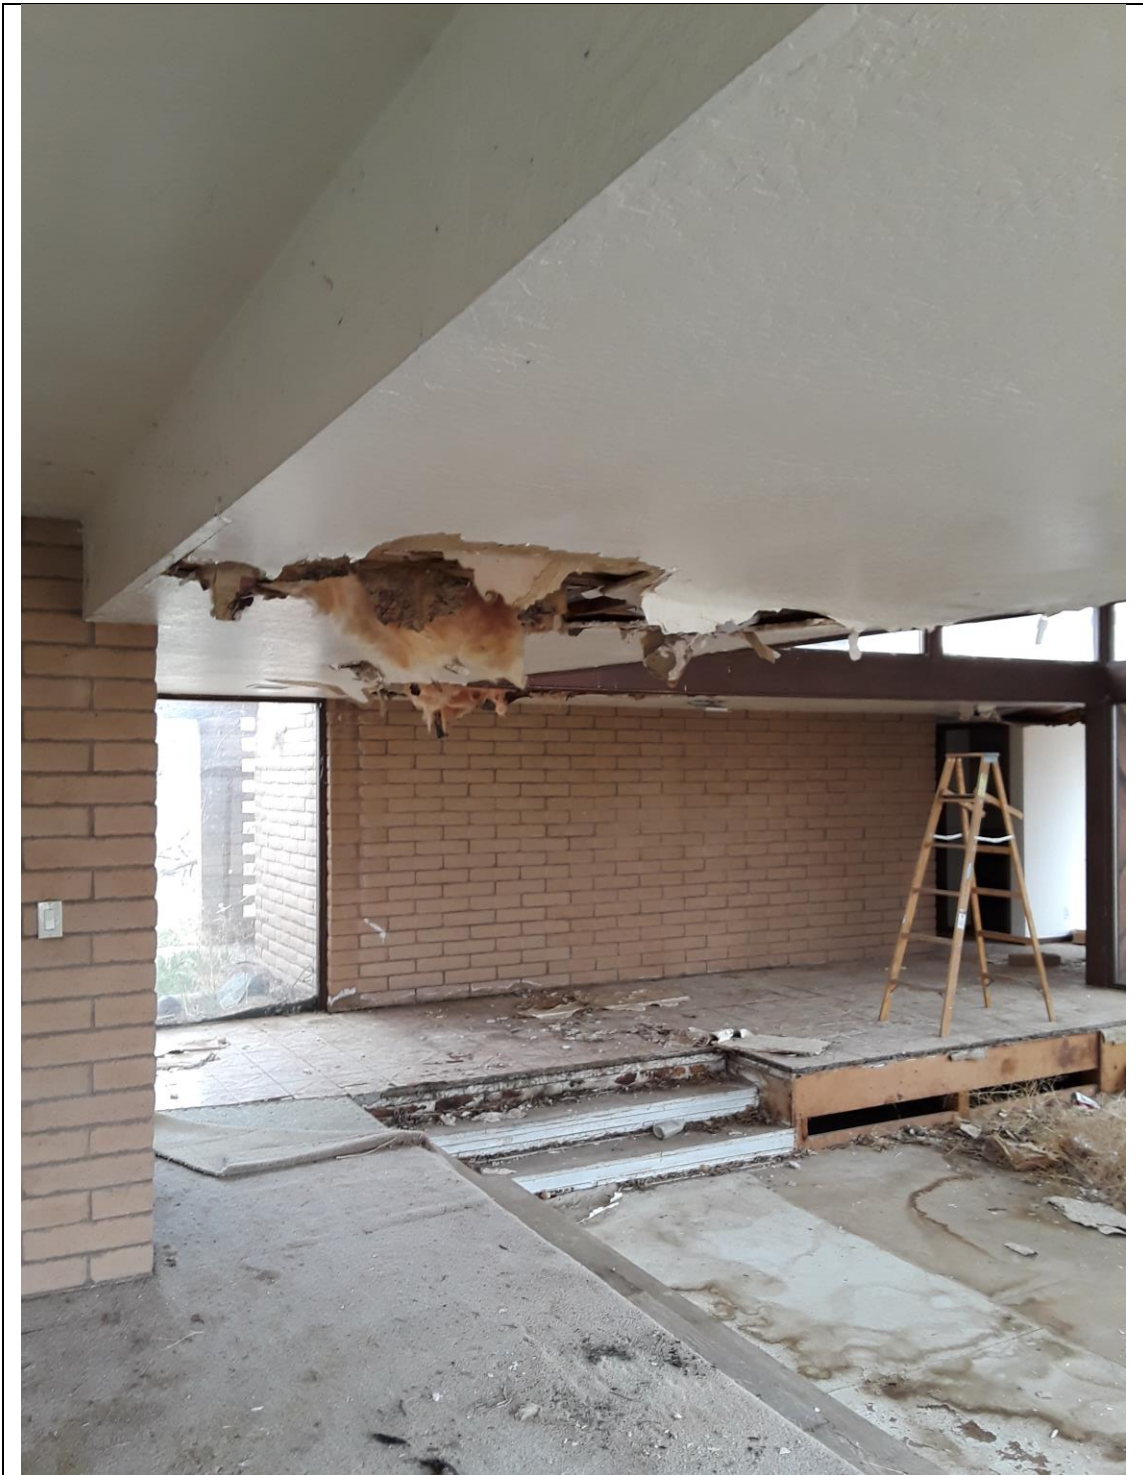
Photograph #2: Lead containing beige floor tile (glaze) in main hallway.

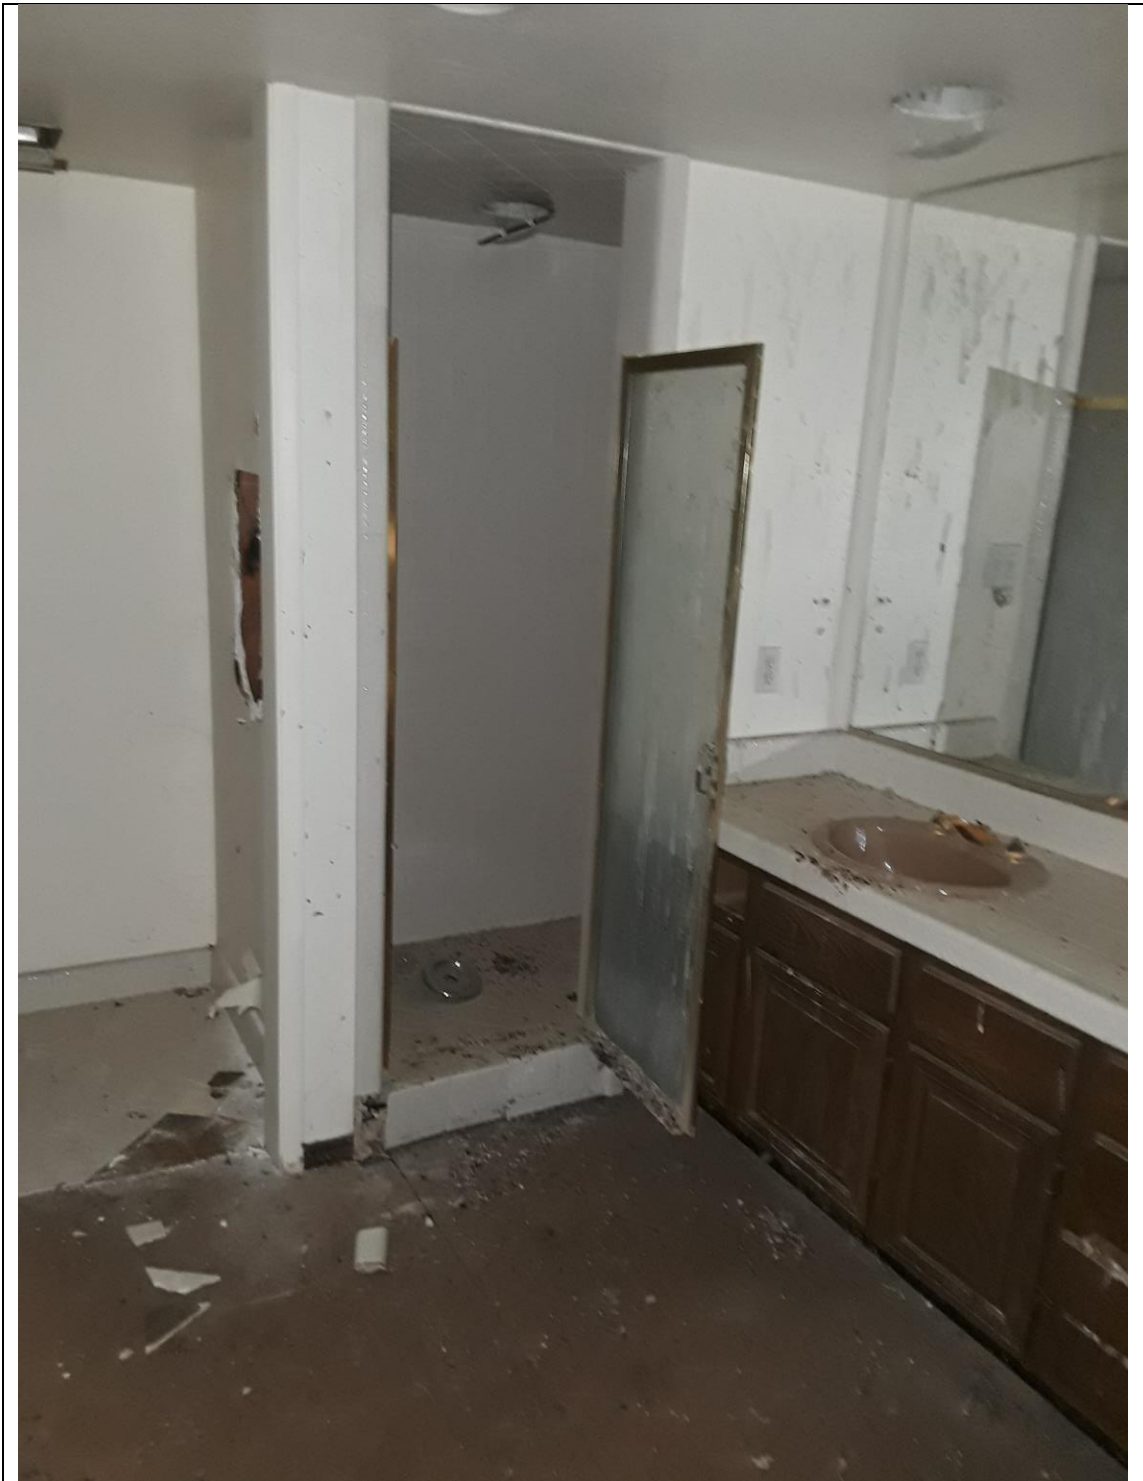
Photograph #3: Lead containing white tile (glaze) in shower/bathroom (LBP).
